# Home Inspection Report

111 Anywhere St.  
Anywhere, TX 77777

## PROPERTY INSPECTION REPORT

**Prepared For:** Your Name  
**Concerning:** 111 Anywhere St Anywhere, TX 77777  
**Inspection Date:** XX/XX/XX  
**By:** Inspector Name: Jay Frampton License Number: 10408 Date:  
Signature:  
Phone: 940-521-4668 License Number 10408  
E-Mail: jay@insightinspectionstx.com

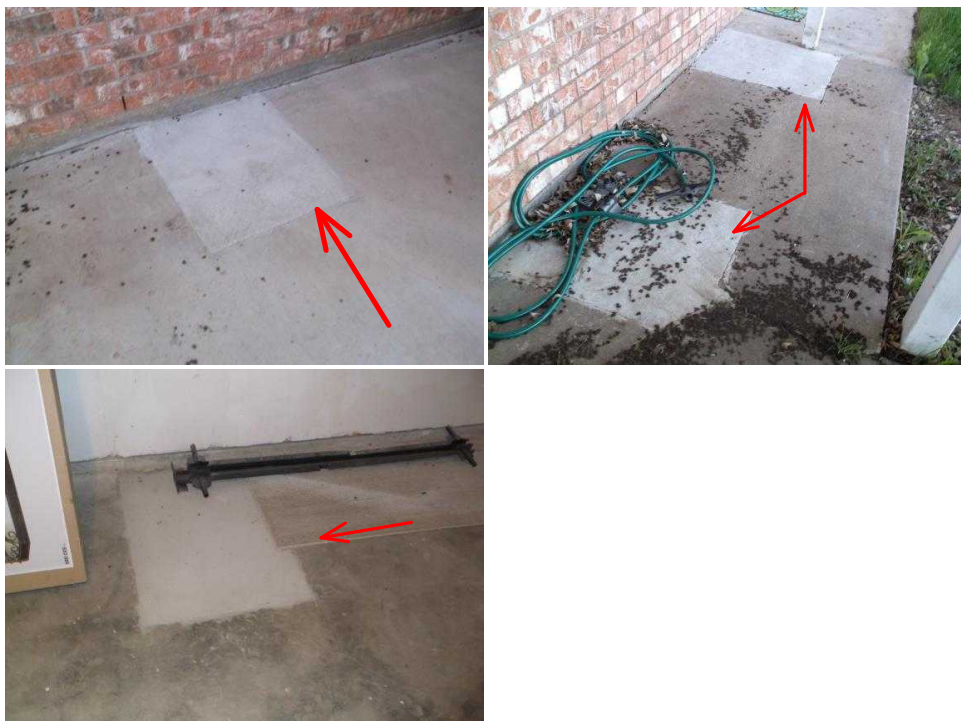
Evidence of past foundation repairs are present, noted several patches in concrete drive and walks which indicated piers were placed to stabilize the foundation. Obtaining the original warranty from the foundation contractor is recommended, as warranty may be transferable to a new owner. In addition the foundation report may have a scaled drawing of the location and type of piers placed.

Continued observation is recommended, If additional concerns exist contact a licensed structural engineer for further evaluation and repairs.

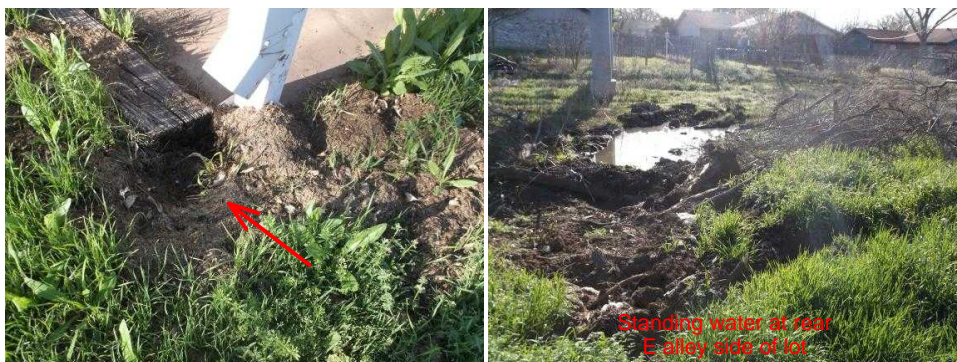
Home is above street grade, storm water appears to shed around the home toward the E and W sides of lot. Noted standing water in the alley or E side of lot, and along neighbors fence toward the N.

Limited guttering is present on this structure. Only on the E porch covering under today's building standards these are recommended around the entire perimeter of the home, to assist in storm water discharge, and minimize erosion.

Recommend installing splash block at the base of the downspout to minimize erosion.

It is recommended that the flow of storm water runoff not be obstructed by addition of flower beds, or walks. Under current building standards, the grading around the home should drop 6" within the first 10' on all sides of the structure.

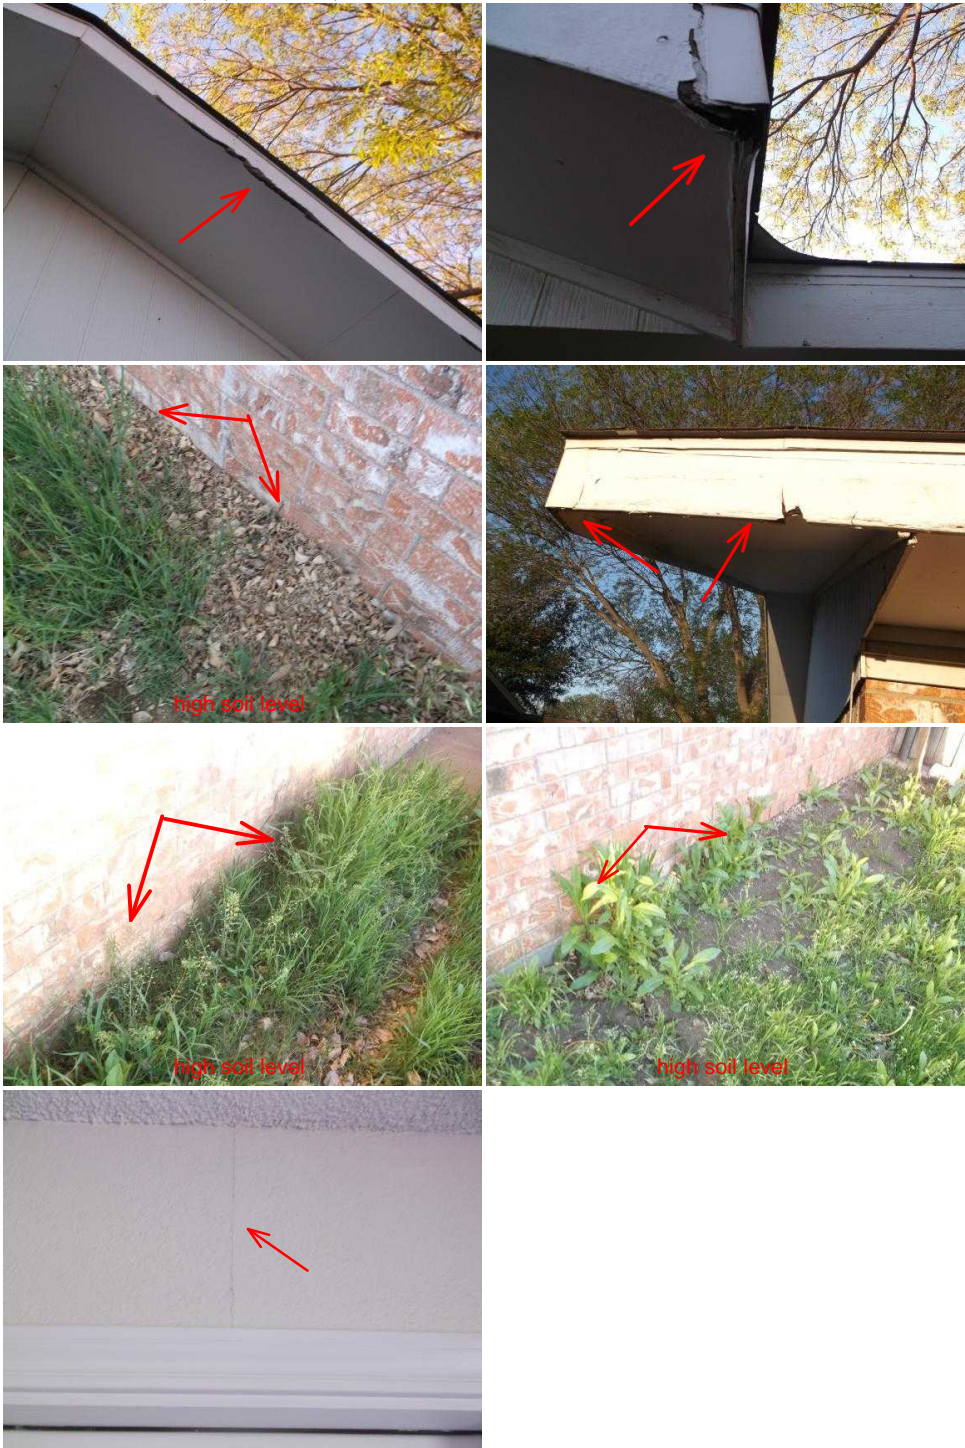
Exterior fascia damage noted in several locations, repairs are recommended and sealing with a quality paint for longevity.

Cracking noted on the drywall above entry to garage. This appears to be due to general settlement of the foundation in the vicinity. Continued observation is recommended.

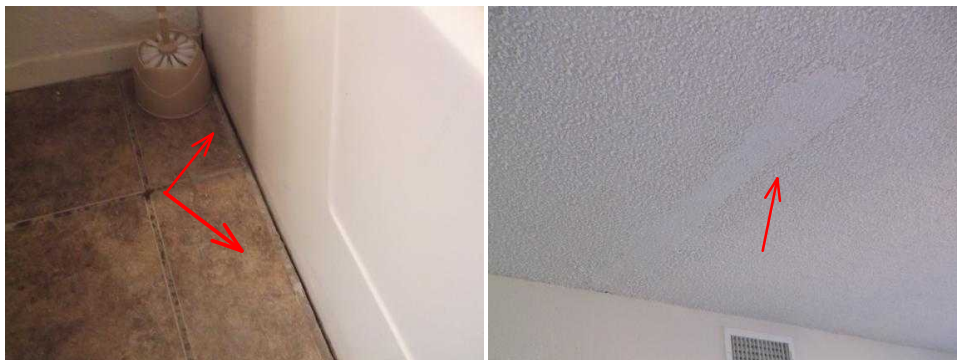
☐☐☐☒ **F. Ceilings and Floors** - Comments: Drywall,  
Sealing the joint between the bathtub and tiled flooring is recommended to ensure no water intrusions occur.

Noted past patching of the ceiling in the living room, continued observation is recommended.

If additional concerns exist contact a licensed, professional building contractor for further evaluation.

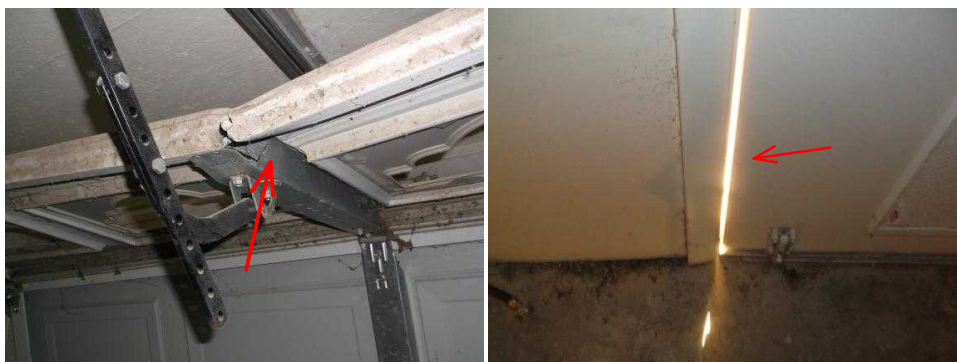
☐☐☐☒ **G. Doors (Interior and Exterior)** - Comments: Hollow wood,  
Overhead garage door upper panel is damaged, repairs are recommended by a licensed professional overhead door contractor.

Weather stripping improvements recommended to the rear E entry door to garage.

Several doors are in need of adjustment to function properly: Master closet door strikes jamb, SW bedroom closet door not properly installed, entry closet rubs the jamb.

If additional concerns exist contact a licensed building contractor for further evaluation.

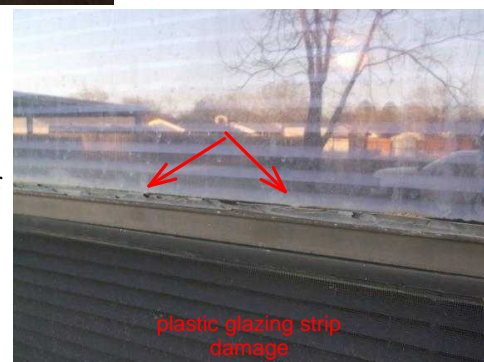
☐☐☐☒ **H. Windows** - Comments: Aluminum single hung,  
Windows appear to consist of the original aluminum framed single hung units.  
The plastic glazing strips on several on the windows have failed.

Thermal seal loss is noted on master bedroom, SW bedroom. This seal loss allows for fogging or condensate to collect between the panes of glass. Further evaluation by a professional window specialist is recommended.

SW bedroom window glass is cracked, appears to have been hit with a bb or something similar.

Window screening missing from dining, living, and master windows.

Tear noted to window screen kitchen sink area.

Cleaning of windows, tracks, and lubrication of all windows is recommended, to ease operation.

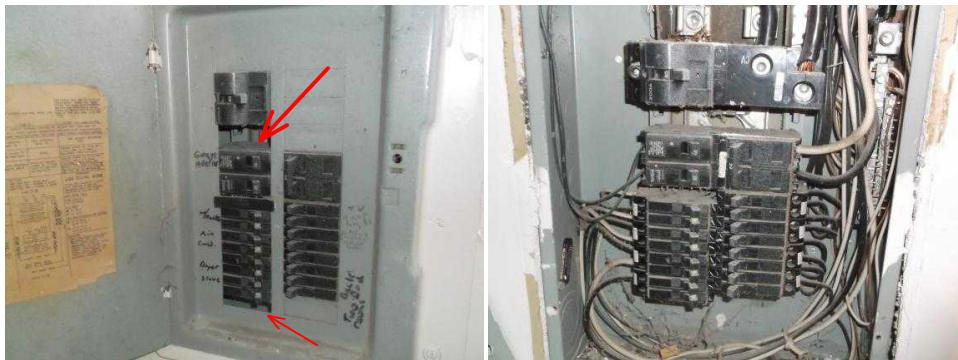
One of the four screws securing the dead front cover was missing at the time of inspection.

Further evaluation by a licensed electrical contractor is recommended.

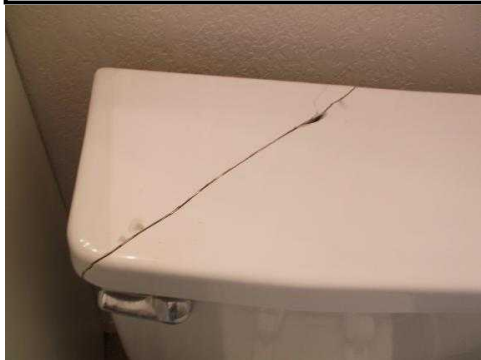
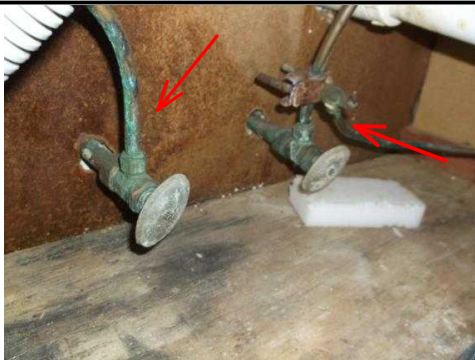
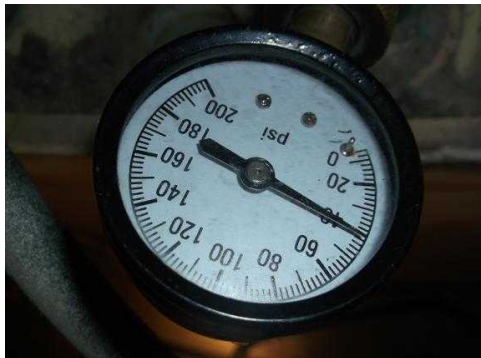
Cracking of the commode tank lid in master bath is present. Recommend replacement of damaged lid.

Greening and corrosion noted at water supply valves under kitchen sink. No leak was present at the time of inspection, continued observation is recommended.

Hose bib on rear E side of home, handle was not present. Repairs are recommended by a licensed plumbing contractor.

Further evaluation by a licensed plumbing contractor is recommended.

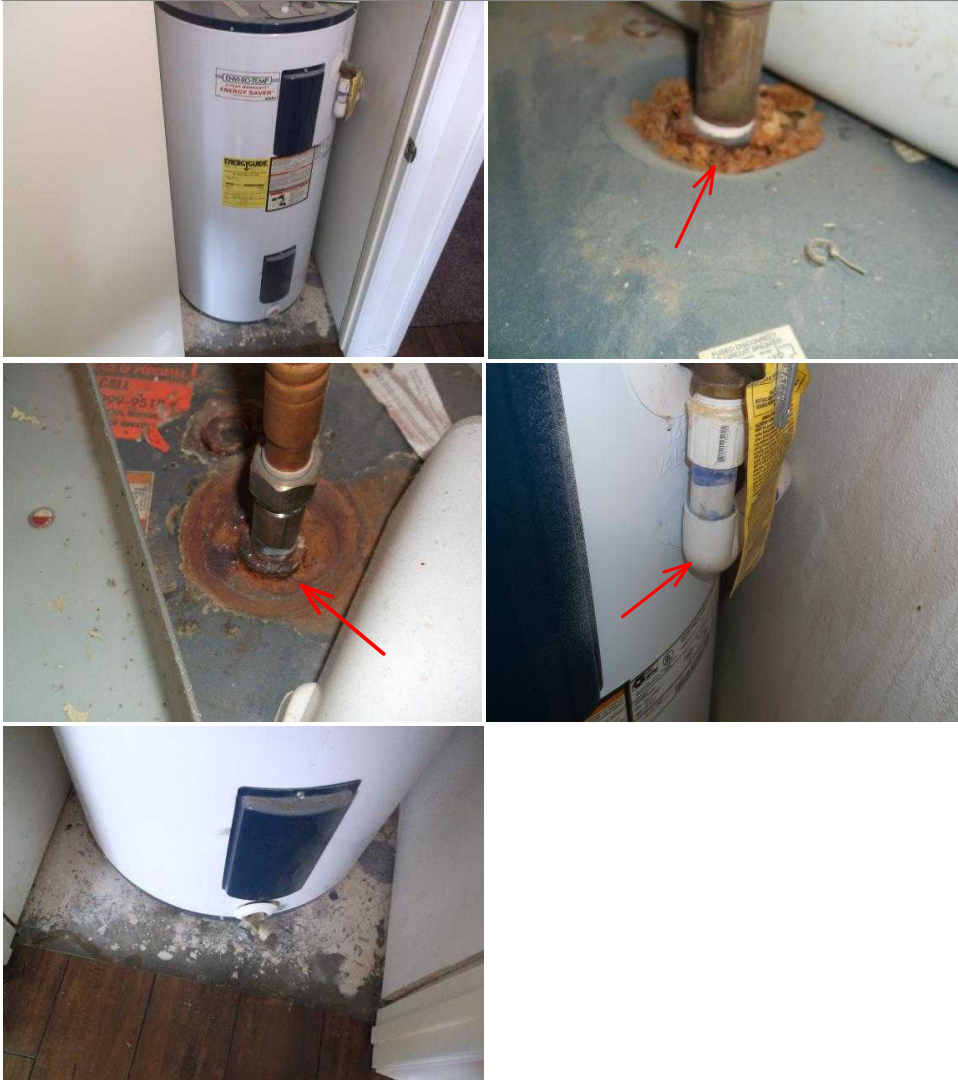
Corrosion noted at the water supply connections. This indicates past water leaking issues. Continued observation is recommended.

The temperature pressure and relief valve is not properly plumbed. It is currently plumbed using PVC, this should be CPVC to withstand heat, the drain line runs uphill through the attic to a plumbing vent stack. This should be directed to the exterior of the home and only be run horizontal or in a downward fashion. Further evaluation by a licensed plumbing contractor is recommended.

No safety collection pan is present under this unit. According to today's building standards a safety collection pan is recommended under any unit that, if leaking may damage the household belongings. This unit backs up to the master closet wall. Installation of a safety collection pan is recommended, and properly plumbed to safely drain away. Contact a licensed plumbing contractor for further evaluation and repairs.

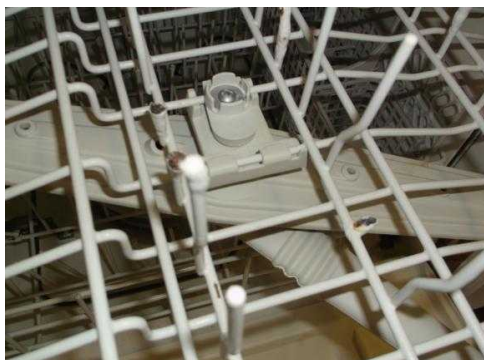
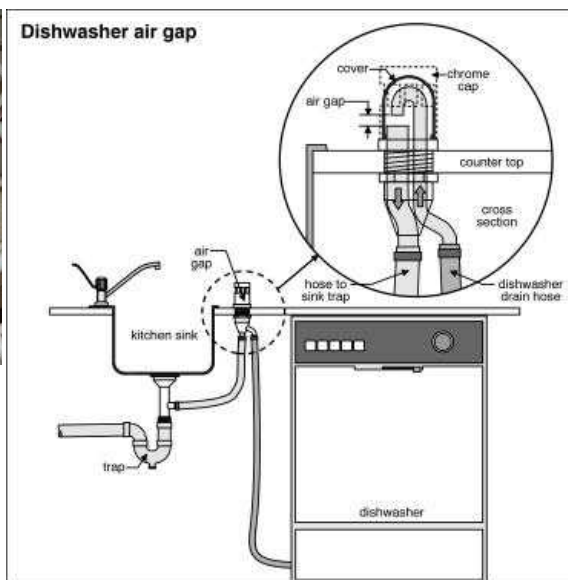
- ☐☐☐☒ **A. Dishwashers** - Comments: Kenmore,  
Corrosion noted on the interior dish baskets, replacement or repair is recommended.

No air gap is present on the drain line of this washer unit. This ensures no back up of water from sink basin into the lower, dish washer unit. This is recommended either by installing an air gap device, or creating an air gap using the drain tubing, in an arched fashion under the sink basin. According to today's building standards.

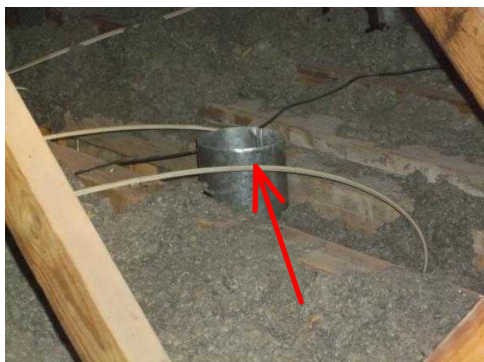
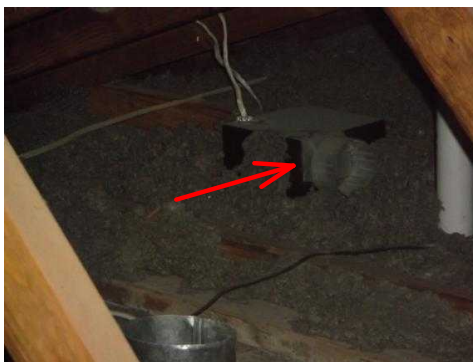
- ☐☐☒ **C. Range Hood and Exhaust Systems** - Comments: General Electric,  
Vents to attic space, under today's building standard this should be directed to the home's exterior surfaces.

- ☐☐☒ **F. Mechanical Exhaust Vents and Bathroom Heaters** - Comments: Bath vent fan vents into the attic space. Under today's building standards this should be directed to the roof's exterior surface. The removal of all moisture from attic space will deter mold and pest activities.

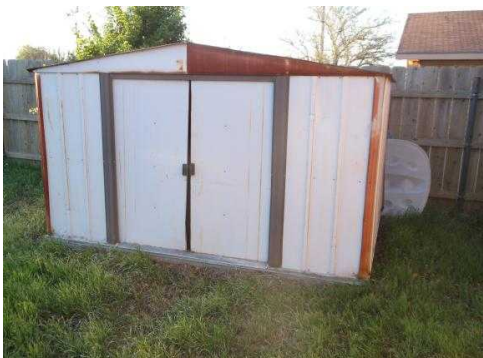
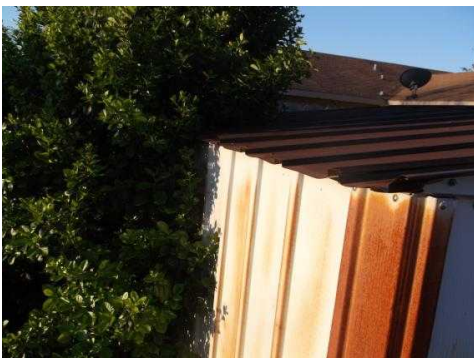
Rusting noted to shed exterior surfaces, consideration to a paint application is recommended to aid in longevity.

Trimming back of tree on SE corner of shed is recommended.
