Home Inspection Report

2222 Anywhere St
Anywhere, TX 77777

PROPERTY INSPECTION REPORT

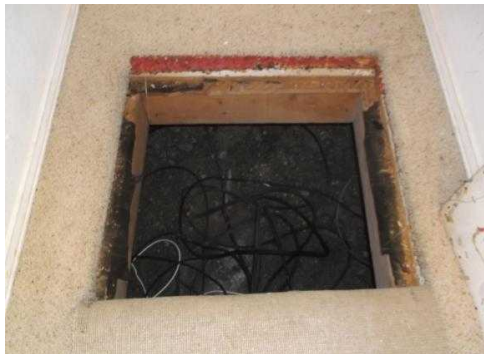
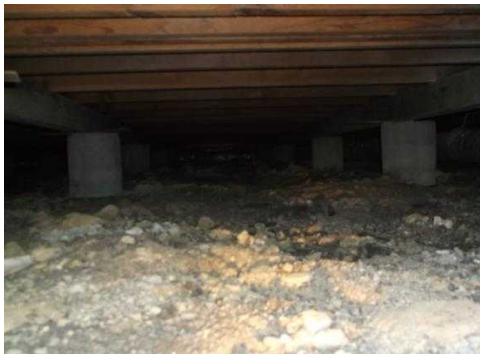
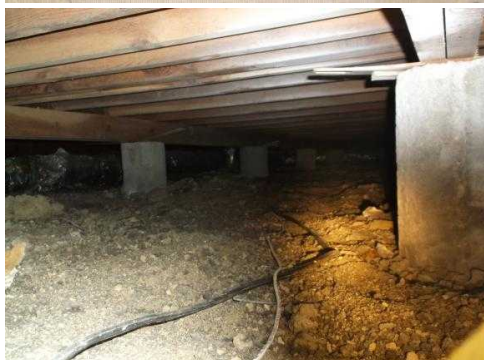
The foundation has had some settlement; the amount of settlement observed is not uncommon to see in this region. This is a cursory and visual observation of the conditions and circumstances present at the time of this inspection.

Cracking of the exterior brick veneer noted on E and W facades, appears consistent with general settlement in the vicinities. Continued observation is recommended, if additional concerns exist contact a licensed professional structural engineer.

Soil under the home was mildly damp at the time of inspection, possible due to ground moisture. Increased ventilation is recommended. If additional concerns exist contact a licensed structural engineer for further evaluation and repairs.

Crawl space access under home provided inside hall closet under stair. Areas under the kitchen and laundry could not be accessed due to limited head room and ducting blockages.

If additional concerns exist contact a licensed structural engineer for further evaluation and repairs.

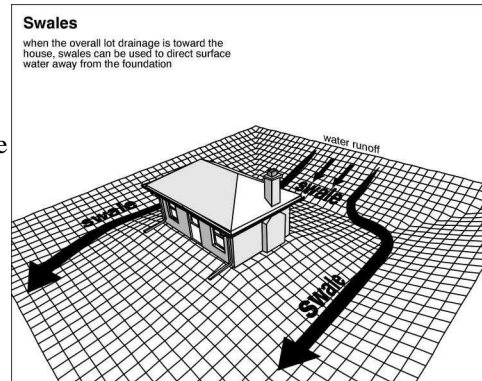
No guttering is present on this structure. Under today's building standards these
are recommended, to assist in storm water discharge, and minimize erosion.

It is recommended that the flow of storm water runoff not be obstructed by
addition of flower beds, or walks. Under current building standards, the
grading around the home should drop 6" within the first 10' on all sides of the
structure.

Periodic inspections of yard during periods of rainfall is recommended to
determine any standing water issues, and resolve as needed.

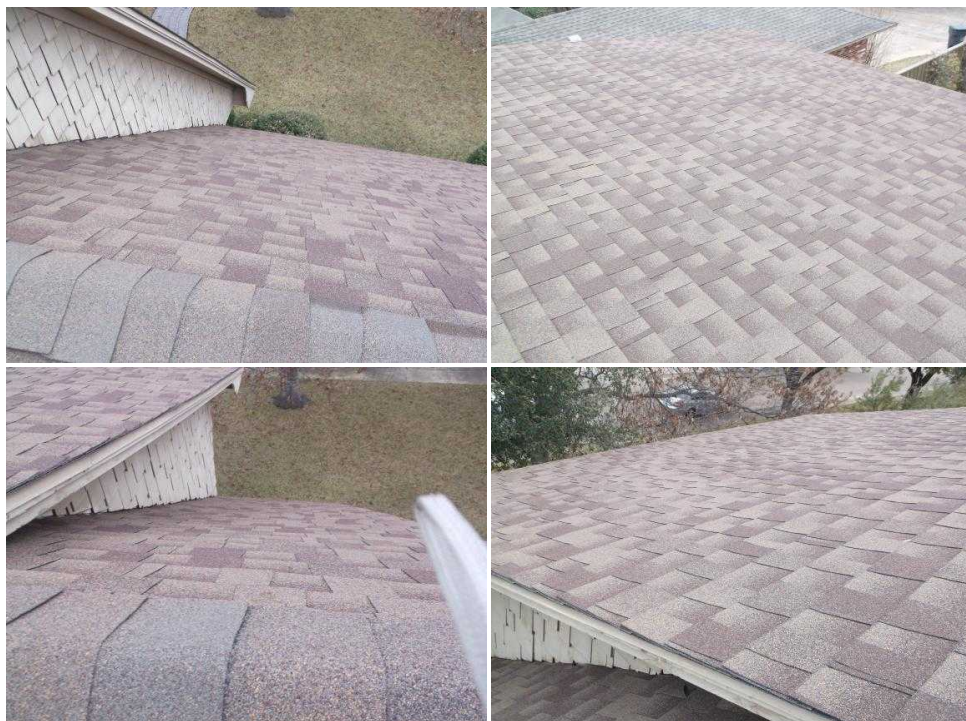
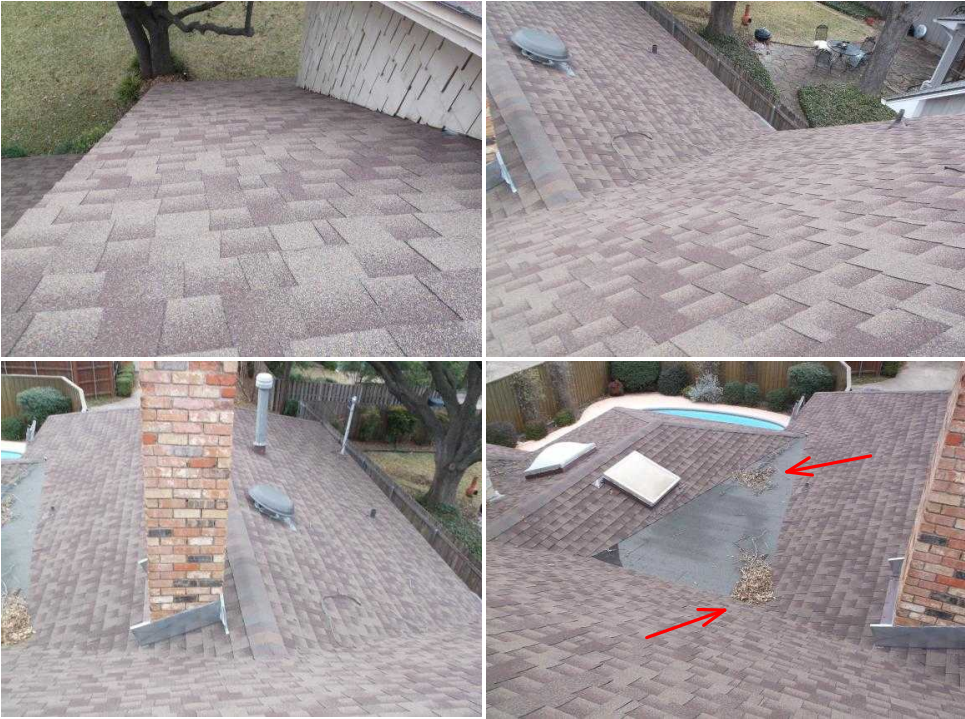
Roof covering appears to function as intended at the time of this inspection. If additional concerns exist contact a licensed,
professional roofing contractor for further evaluation.

General observation: Removal of tree debris from roof covering is recommended, as this can aid in insect intrusions and
moisture issues.

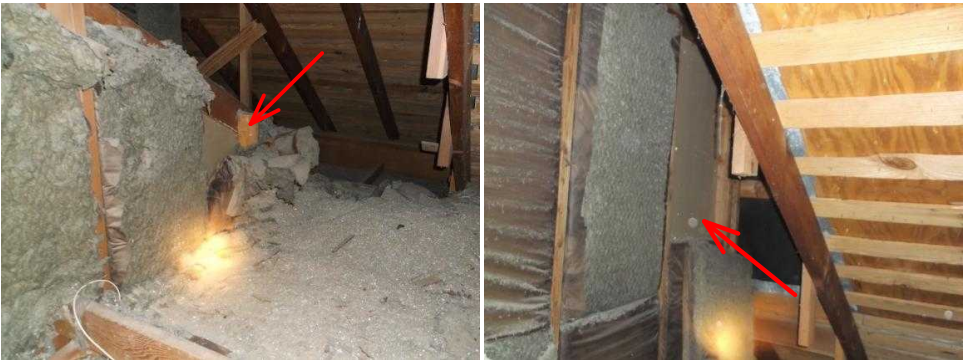
Attic insulation levels currently in the attic space is below the minimum level for a home built today. Today's building standard is R38 value, which is equal to approximately 18-20" of blown in loose fill type insulation. The additional insulation will help significantly reduce your energy consumption.

Vertical fiberglass batt insulation is pulling away securing is recommended. This insulated portion of the wall appear to be the upper stairwell wall.

If additional concerns exist contact a licensed, professional building contractor for further evaluation.

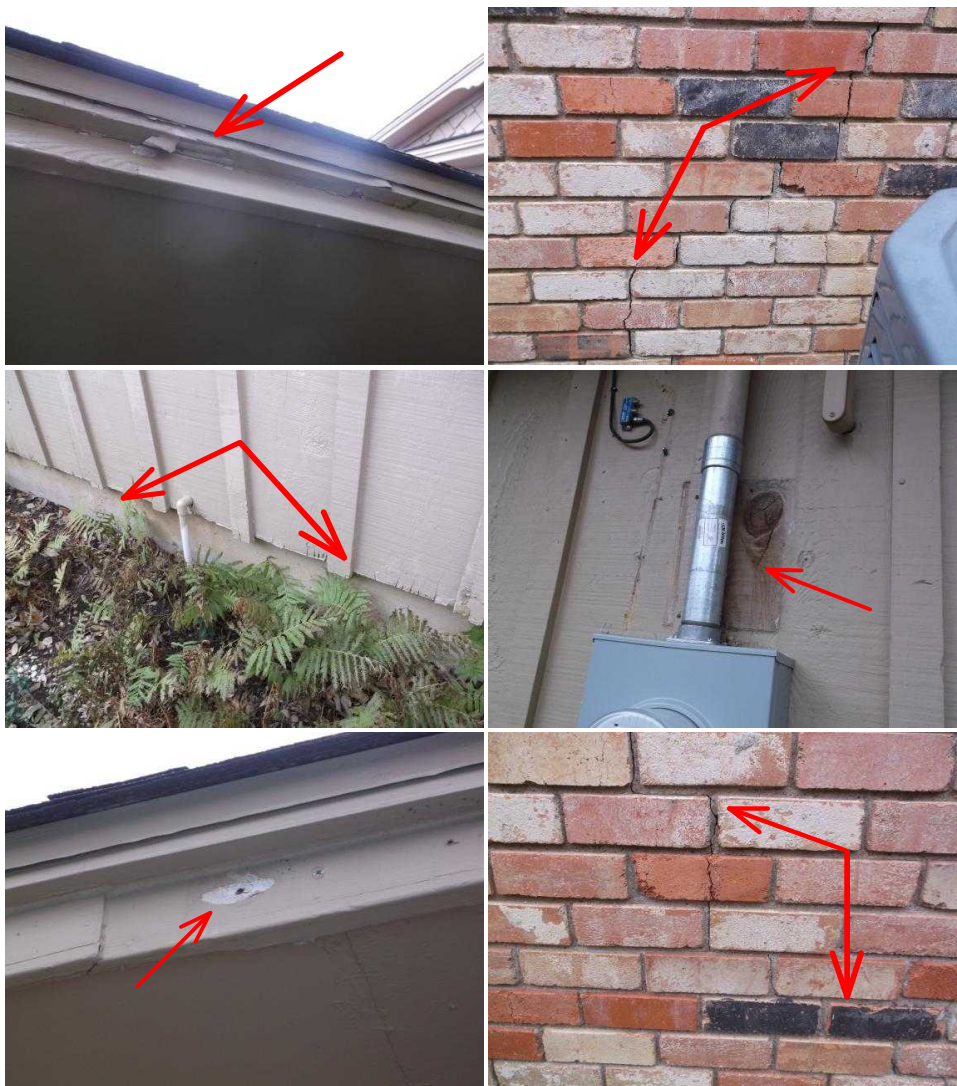
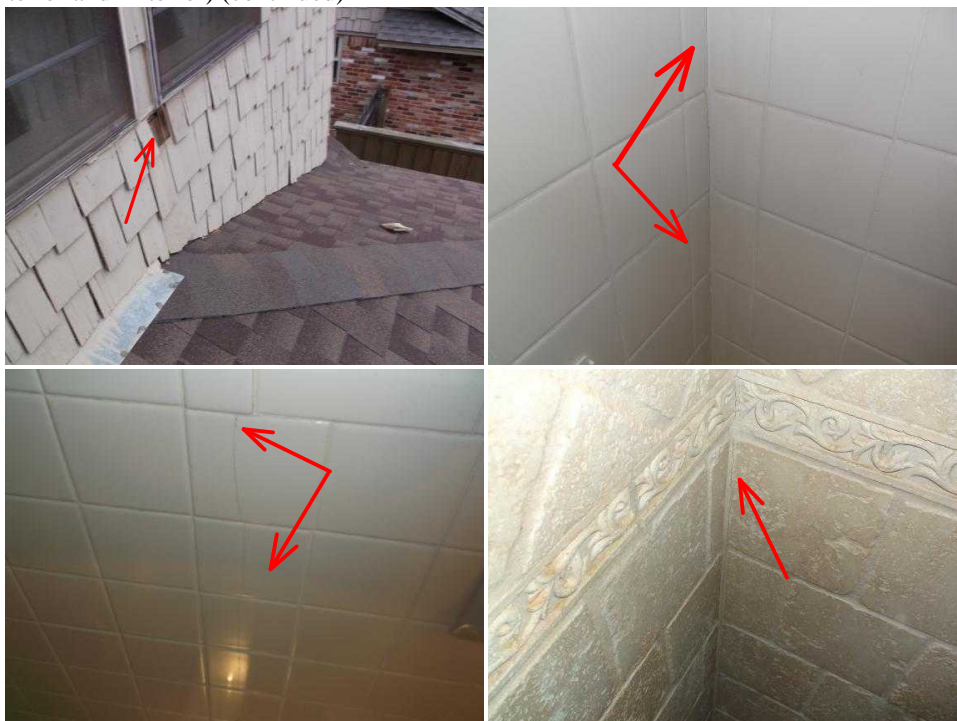
Loose peeling paint noted in several locations around fascia and soffit areas, recommend scraping, and sealing with quality paint for longevity.

Base of vertical siding on W facade display wood rot, continued observation and repair as needed.

Unpainted wood noted in vicinity of electric meter base, recommend sealing with quality paint for longevity.

Loose wood shingle on S exterior wall noted, replacement is recommended.

Cracking of interior grouted joints in shower surround noted, recommend regrouting or sealing with approved sealant to prevent water intrusions behind tiled surfaces.

If additional concerns exist contact a licensed building contractor for further evaluation.

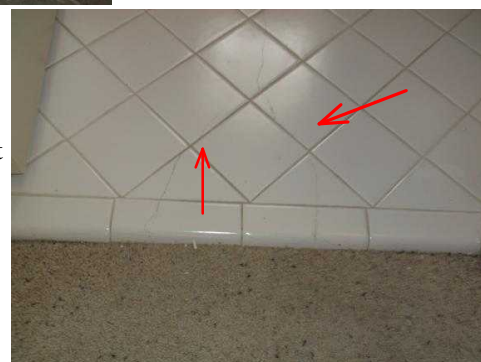
☐☐☐☒ **F. Ceilings and Floors** - Comments: Drywall, Cracking of the flooring tile upstairs bathroom is noted, continued observation and repair as needed.

Staining of interior water heater drywall ceiling noted, appears to be due to past water intrusions, continued observation is recommended. Area appears dry at the time of this inspection. If additional concerns exist contact a licensed, professional building contractor for further evaluation.

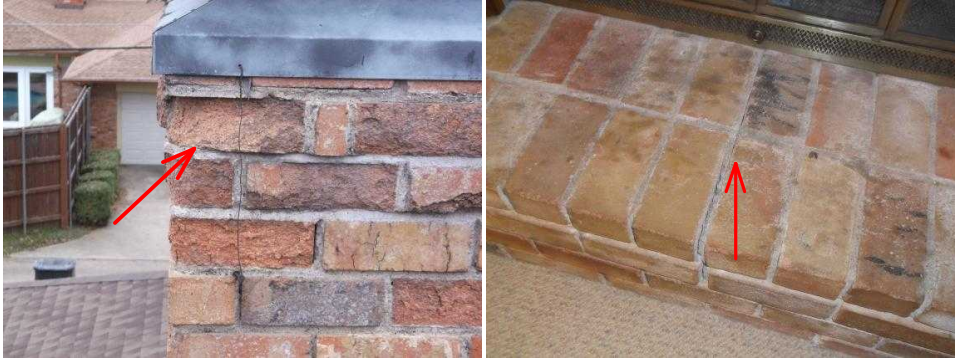
Spalling of exterior brick noted on upper chimney surface, this occurs over time as the brick ages, and due to the freeze / thaw cycles. Continued observation and repair as needed.

Damper blocking is required under today's building standards for gas log units. This blocks the damper so continual exhausting of combustion gasses occurs.

If additional concerns exist contact a licensed professional chimney fireplace contractor for further evaluation.

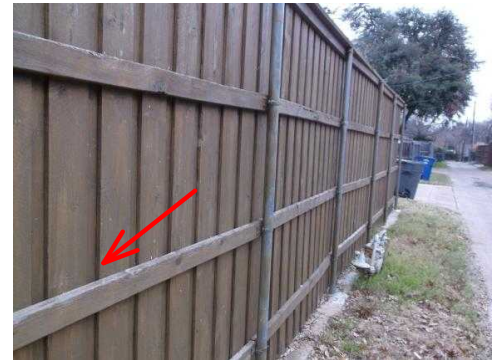
General observation: Sealing of wood fencing is recommended on a periodic maintenance schedule to aid in longevity of wood supports and surfaces.

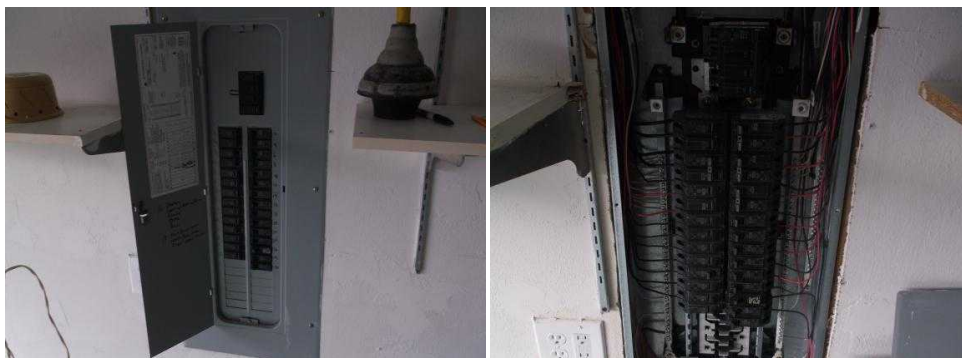
Service panel appears to have been upgraded from original service panel, as a junction box is present directly above panel.

Service panel appears to function as intended at the time of this inspection. If additional concerns exist contact a licensed electrical contractor for further evaluation.

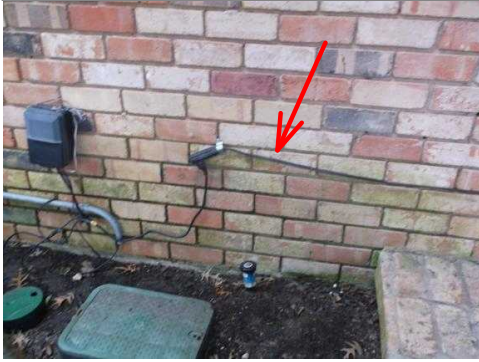
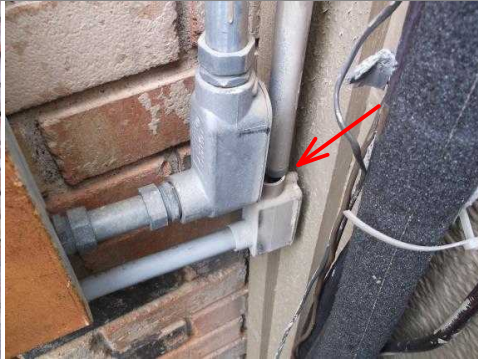
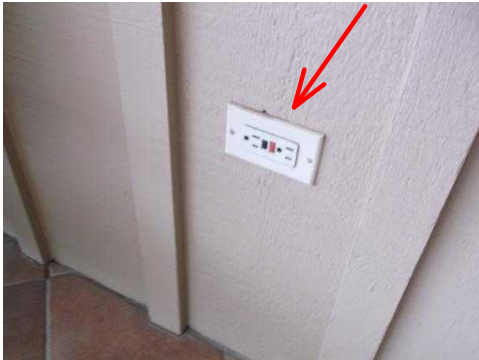
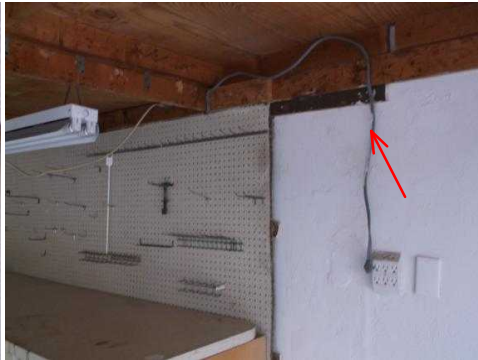
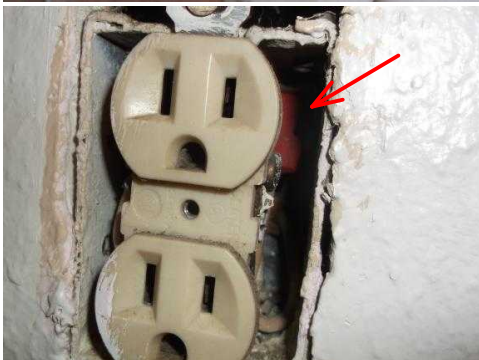
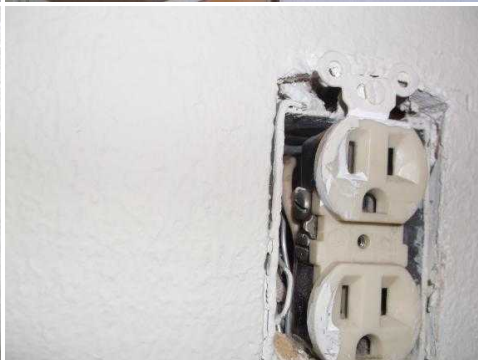
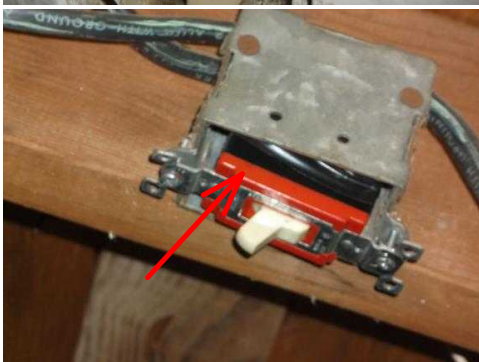
Permanent use of extension cording noted on front N exterior wall and inside garage. This is no longer an acceptable practice.

Loose conduit and junction box noted on exterior W wall, securing is recommended.

Open switch box noted in garage attic space, proper switch cover should be installed.

Hot and neutral reversed polarity outlet noted in master bath, and upstairs closet / office.

Open grounding noted in several outlets and indicated with orange sticker dots: entry way, dining, living room, and laundry.

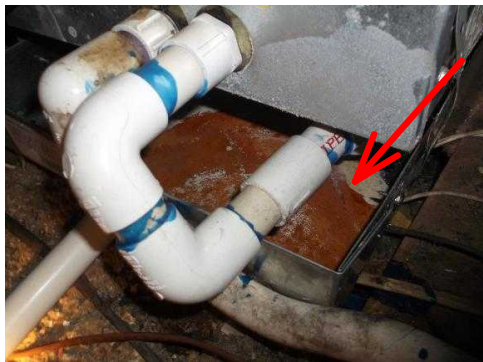
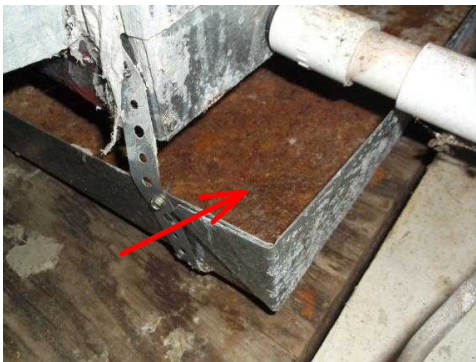
Rusting inside secondary collection pan indicates the primary condensate drain line has backed up in the past. Continued observation and repair as needed.

If additional concerns exist contact a licensed HVAC contractor for further evaluation.

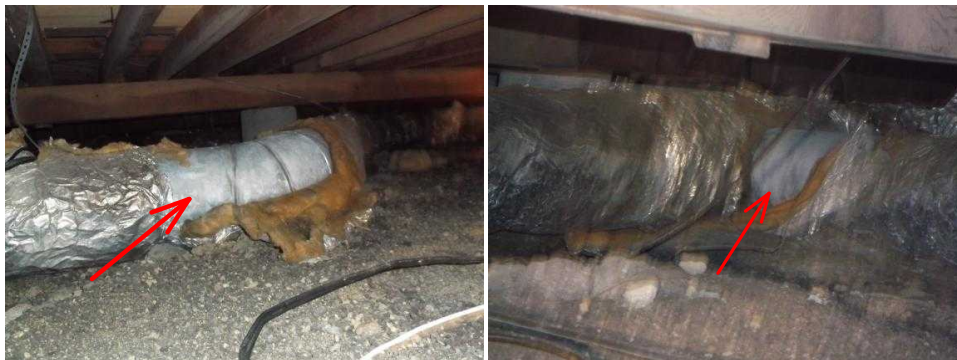
Ducting insulating blankets under the home have been dislodged, recommend repairs and securing.

Under today's building standards, ducting under the home should not be in contact with the ground, this is present in several locations.

If additional concerns exist contact a licensed HVAC contractor for further evaluation.

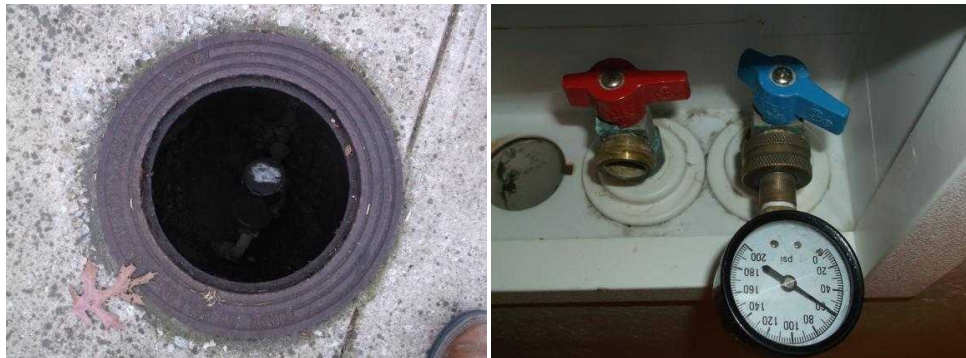
Anti-siphon vacuum breakers are recommended under today's building standards to be used on each exterior hose bib. This will minimize the potential of contaminated potable water.

If additional concerns exist contact a licensed plumbing contractor for further evaluation.

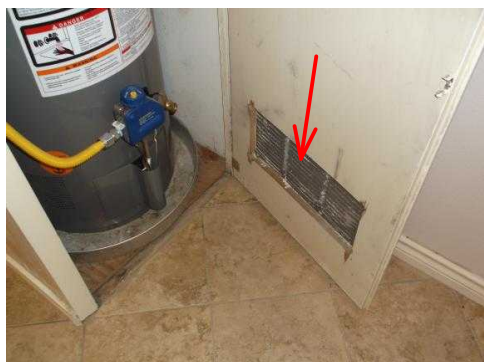
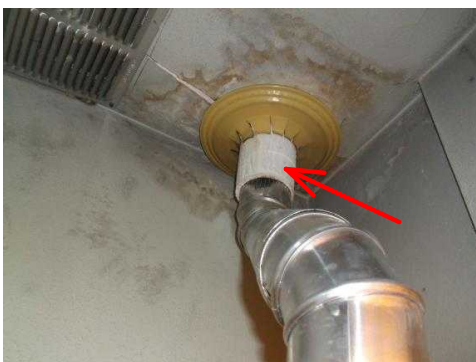
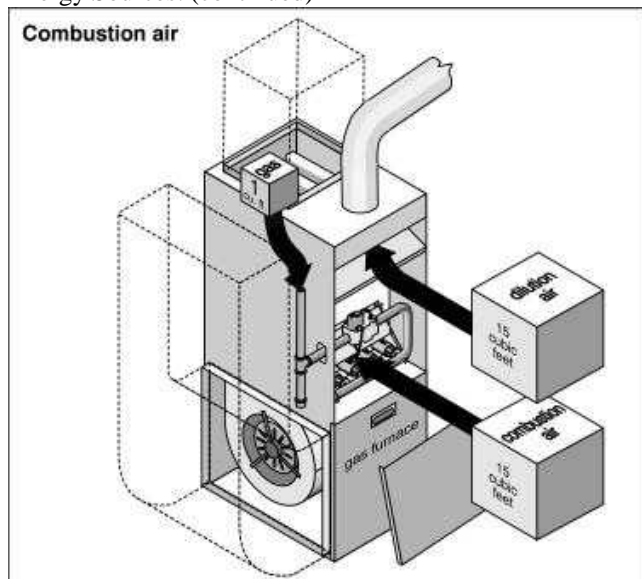
Combustion air used for this unit is partially supplied from interior air. It is recommended that all interior air be blocked off, ideally with a solid door, forcing all combustion air from inside the attic space. The concern is carbon monoxide buildup. Further evaluation by a licensed HVAC contractor is recommended.

Vent pipe through attic appears to consist of asbestos type flue pipe. If additional concerns exist contact a licensed professional plumbing contractor for further evaluation.

If additional concerns exist contact a licensed plumbing contractor for further evaluation.

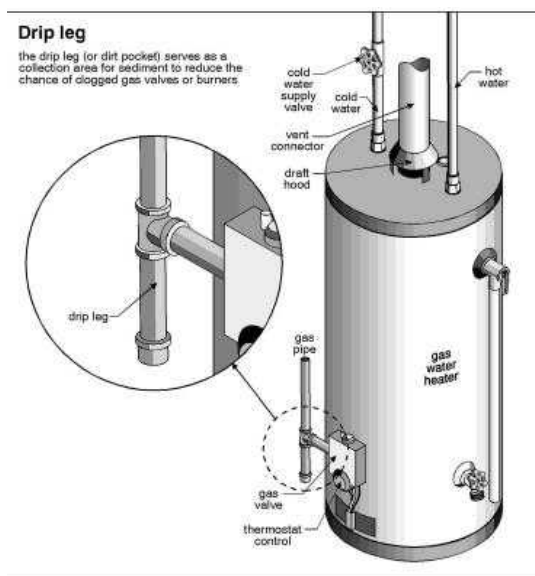
Sediment traps, required as close as possible to all gas fired appliances, under today's building standards. IRC09-2419.4 Further evaluation by a licensed plumbing contractor is recommended.

If additional concerns exist contact a licensed plumbing contractor.

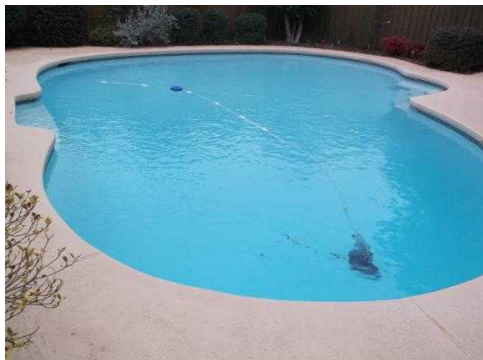
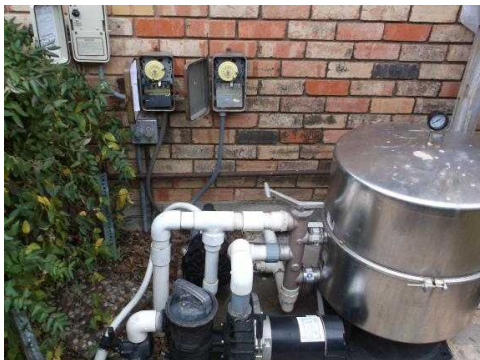
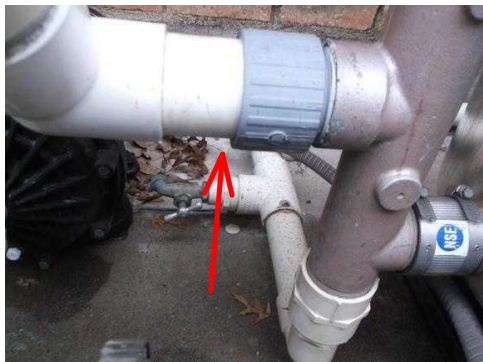
- ☐☐☐☒ **B. Swimming Pools, Spas, Hot Tubs, And Equipment**
Type of Construction: Gunnite with plaster
Comments: In ground
Grounding and bonding of pumps to the ground is recommended under today's building standards. In addition the pumps should be connected to a GFCI protected breaker.

Small leak noted during operation at the discharge side of main pump prior to filter.

Homes with swimming pools should have a gate which self closes or swings shut after each opening.

If additional concerns exist contact a licensed pool contractor for further evaluation and repairs.
