# Home Inspection Report

111 Anywhere St.  
Anywhere, TX 77777

## PROPERTY INSPECTION REPORT

**Prepared For:** Your Name  
**Concerning:** 111 Anywhere St Anywhere, TX 77777  
**Inspection Date:** XX/XX/XX  
**By:** Inspector Name: Jay Frampton License Number: 10408 Date:  
Signature:  
Phone: 940-521-4668 License Number 10408  
E-Mail: jay@insightinspectionstx.com

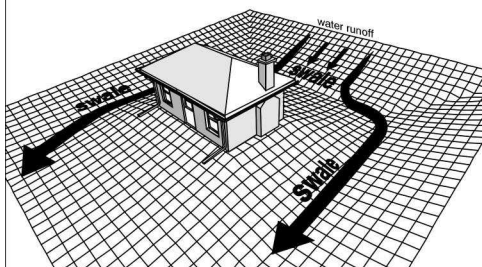
**Swales**

When the overall lot drainage is toward the house, swales can be used to direct surface water away from the foundation.
